CITY OF DALLAS

SUBJECT **Assessment of Dallas City Hall**

Assessment of Dallas City Hall

February 23, 2026

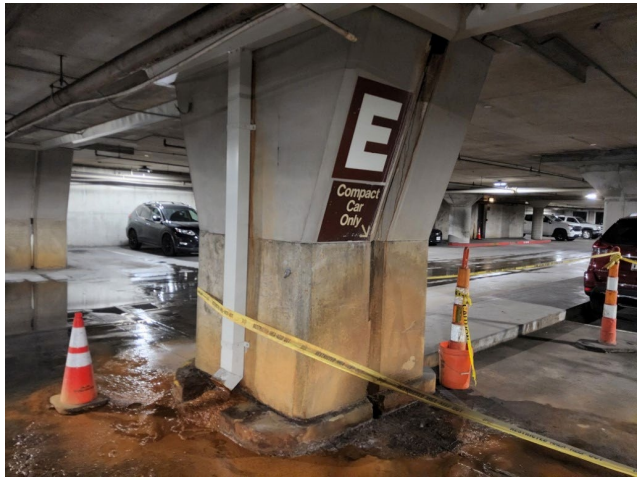
Deteriorated Roof Membrane

Garage water intrusion managed by gutter and downspout

Original HVAC Equipment with Corroded Piping

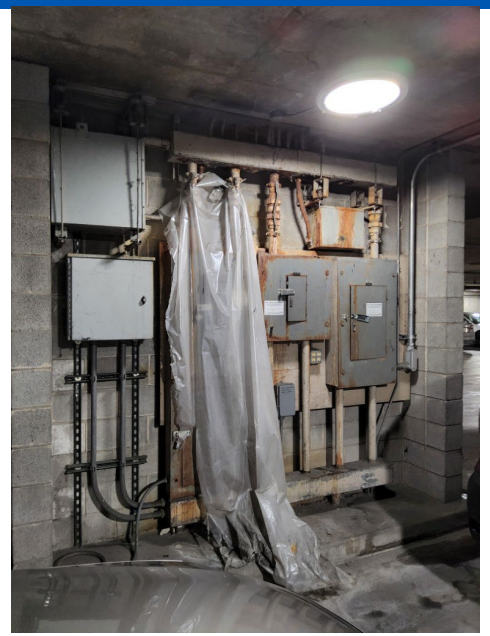
Corrosion on Mechanical Piping

Deteriorated Finishes

Aged Electrical Distribution

Water Intrusion walls

- Comprehensive Emergency Power System Replacement
- Electrical Infrastructure Replacement
- HVAC System Upgrade
- Roof Replacement
- Replace Aged/Obsolete Clean Agent Fire Suppression Systems and Address Garage Fire Suppression Piping Reliability
- Building-Wide LED Lighting and Controls Upgrade
- Comprehensive Waterproofing and Plaza Deck Rehabilitation
- Garage Structural Concrete Rehabilitation

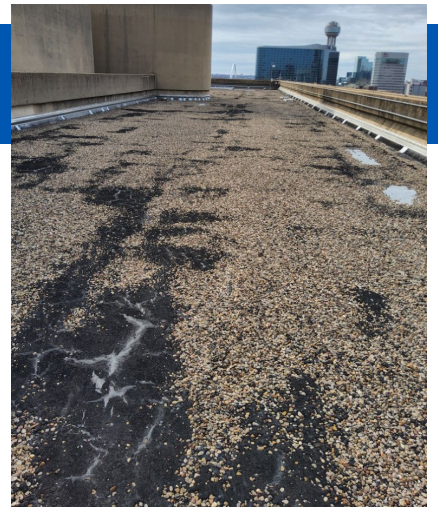
- Built-up and modified bitumen roof systems exhibit widespread deterioration including open flashings, membrane blistering, and base flashing failures.
- Ongoing maintenance is reactive and no longer effective long term.

Typical condition of roof membrane, exhibiting widespread surface deterioration and nearing end of typical service life.

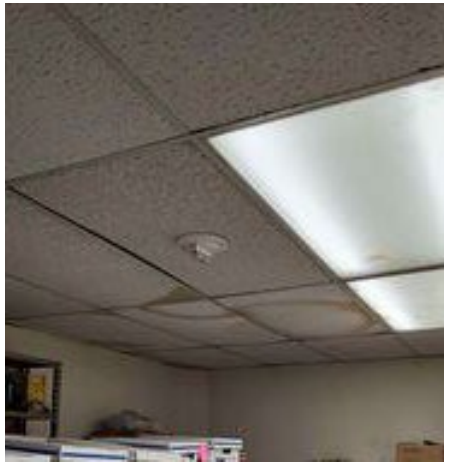
- Water-stained ceilings, damaged finishes, and localized deterioration were linked to roof and garage water intrusion.
- Aged and deteriorated interior flooring including Floor 2 and data center raised access flooring.

Corroded interior door of parking garage interior stairwell

Water-stained ceiling tiles

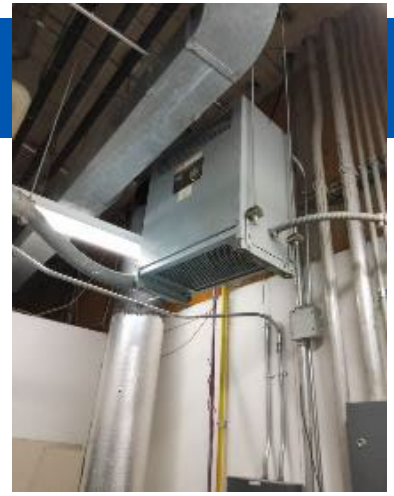
- Legacy electrical equipment has exceeded typical service life and presents increased risk of failure with lack of parts availability. City has confirmed multiple sub-transformers contain polychlorinated biphenyl (PCB)-containing oil.

Aged electrical distribution equipment serving critical building and parking garage equipment.

Original switchgear has exceeded typical service life

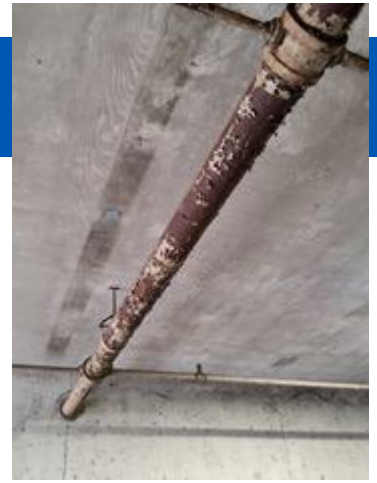
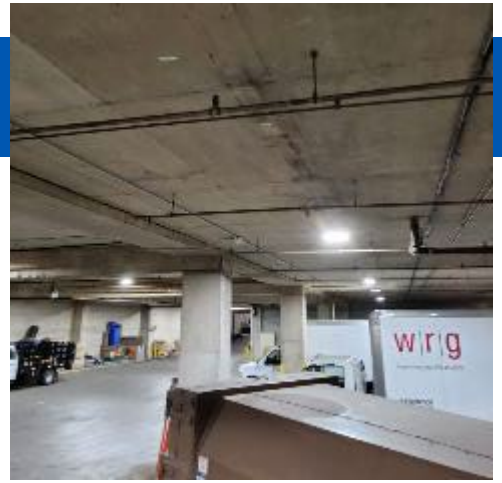
- Large portions of the sprinkler and standpipe systems serving both the Dallas City Hall building and the parking garage were original or of similar vintage, exceeding typical service life expectations.
- Floors 1 thru 6 do not meet current construction standards (standpipe and fire extinguishers only)
- Several fire suppression systems were installed in earlier building modernization phases and utilize clean agent technologies that are now considered obsolete.
- Recurring nuisance alarms reported in the parking garage due to deterioration of the fire suppression piping.

Corroded fire suppression piping indicative of aging sprinkler infrastructure in parking garage.

Fire suppression wet system

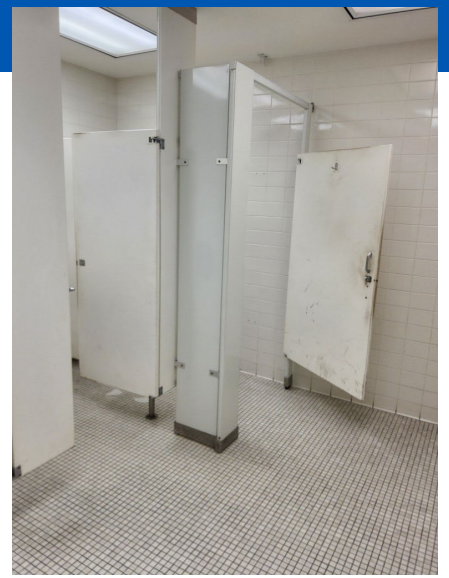
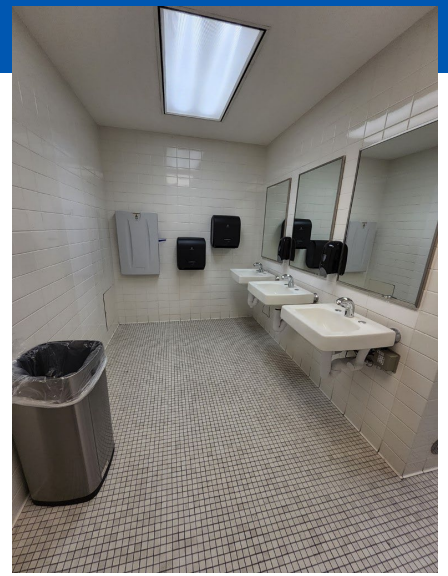
- The 7th floor cafeteria had inadequate grease management infrastructure, constraining food service operations and requires a new grease interceptor with structural modifications to support piping system.

Restroom facilities aesthetically dated and approaching planned refresh cycle

Undersized grease trap serving 7th floor cafeteria

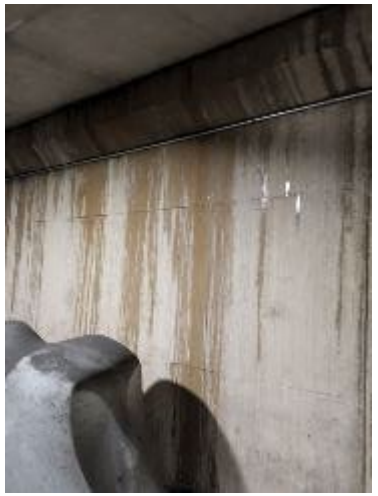
- Ongoing leakage observed at plaza deck assemblies, garage expansion joints, wall/slab interfaces, and building-to-garage transitions.
- Moisture migration into the interior building spaces was confirmed.

Example of gutter system to capture leaking water at IT space within building interior

Coal tar pitch dripping at expansion joint directly above the gutter system installed to capture leaking water

Water intrusion on parking garage walls

Failed expansion joint in parking garage

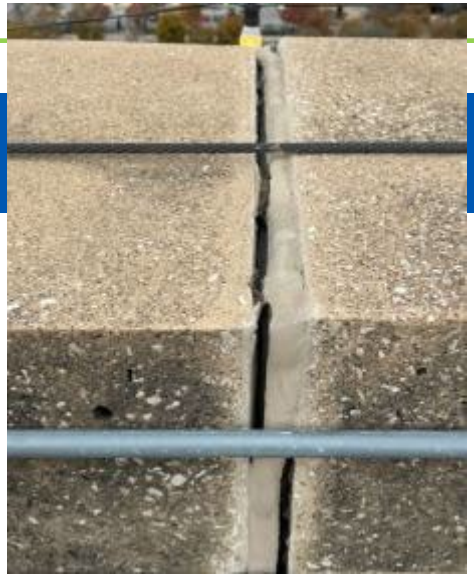
- Localized spalling with exposed reinforcement was observed at select beams, columns, slab edges ramps, and planter interfaces at both the Dallas City Hall building and the parking garage.
- Cracking was noted in the basement walls, garage slabs, and north side and roof level exterior walls.

- Structural interfaces between the Dallas City Hall building and the parking garage exhibited cracking and distress at expansion joints.
- Moisture exposure at these interfaces increase the risk of long-term durability issues.

Spalled concrete with exposed reinforcement observed at City Hall slab edge, indicating localized structural deterioration.

Cracking of roof parapet wall.

Cracking and distress at expansion joints, signs of water intrusion.
